Refurbishment work to Willaston Memorial Hall, The Green, Willaston

Further to recent comments regarding the re-pointing works to the Memorial Hall as part of the maintenance and refurbishment work, we wish to clarify the situation to prevent further inaccuracies.

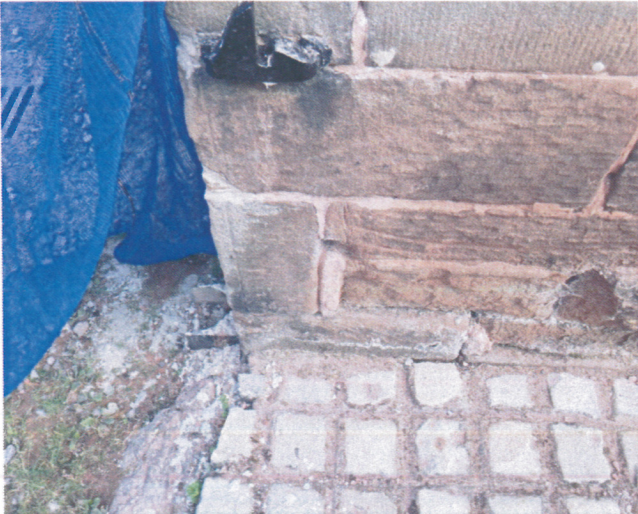
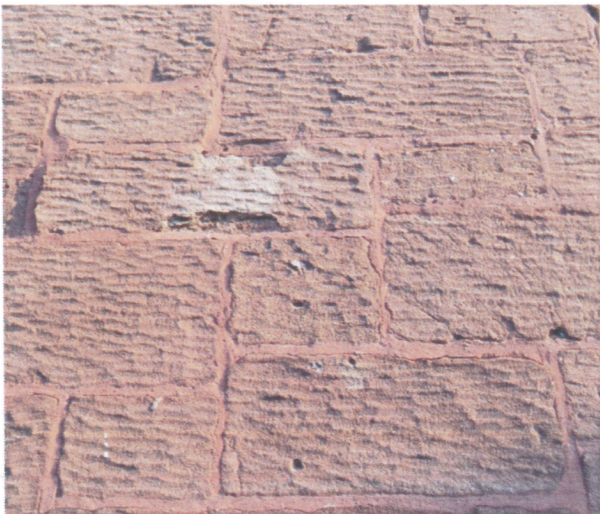
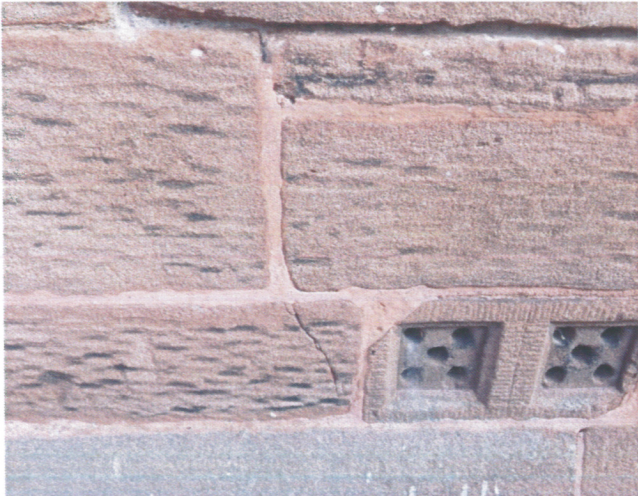
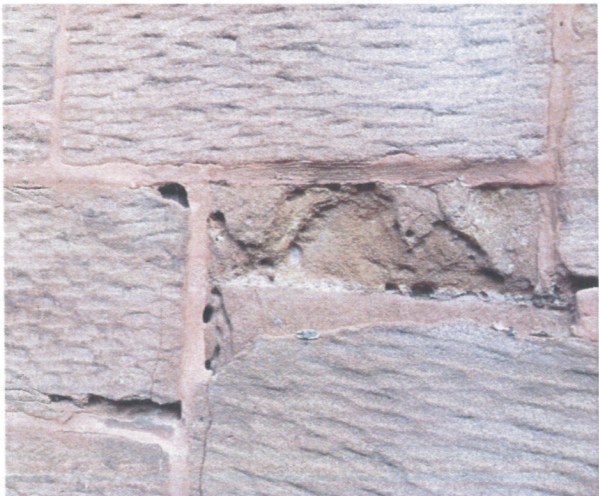
The existing elevations to the front side and rear of the Memorial Hall have red sandstone facings with horizontal joints varying from 8 – 20mm, with an average of around 12mm and vertical joints, slightly narrower, at 6 – 15mm, at an average of 10mm. As stated it was important to remove the red dyed sand and cement mortar to prevent further deterioration to the red sandstone, see photographs.

We are also aware of the comments regarding the colour of the new mortar which you will see from the photographs is close to that of the original. This mortar will, over the next 18 – 24 months, fade in its stark appearance due to natural curing and atmospheric pollution.

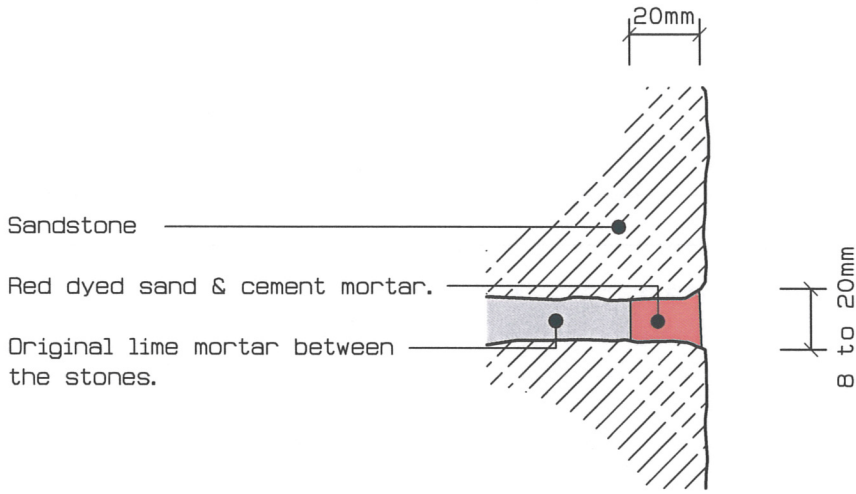
Existing Joints

It is important to understand the reasons why the present cement pointing is deteriorating the building envelope. It is well documented that Portland cement and sand pointing, particularly stronger mixes are not porous and by their very nature shrink as they set and thermally move at a different rate to the surrounding masonry. They further cause erosion of the surrounding soft material which is clearly in evidence with the red sandstone on the Memorial Hall elevations.

A specification was drawn up and included in the documentation forwarded to the tenderers and called for the careful raking out of all mortar joints within the stonework to each of the elevations and chimneys to a depth of 20mm. The joints were to be cleaned and re-pointed with 3.5NHL lime mortar using an Anglesey grit sand. A sample panel was to be prepared at the start of the contract for approval by the Conservation Architect and then used as a standard for the remaining works.

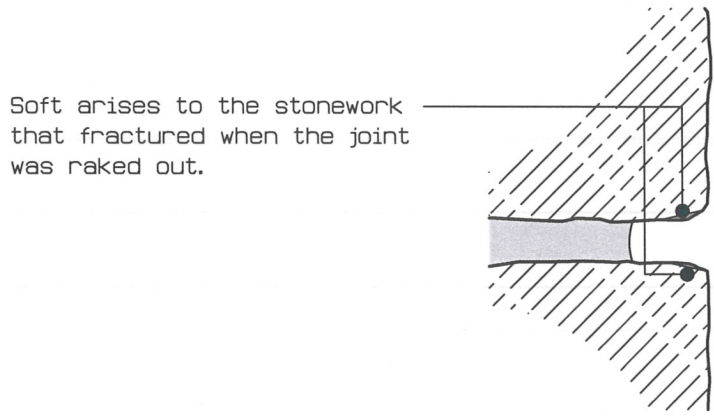
Problem Encountered with the Raked Joints

At the start of the contract a sample area of pointing was raked out with hand tools, as per the specification, and repointed with the approved lime mortar. It was evident from this sample panel that, despite careful raking out to remove the hard cement mortar, the soft sandstone arises were fracturing due to their adhesion with the old cement mortar. This had the undesired effect of widening the joints (mainly the horizontal plane). As a result of this other options were tried to rake out the joints but in all cases resulted in a similar widening.

In a normal situation we would not allow the use of mechanical cutters to remove old mortar but in this instance it was found that by using a thin blade cutter to cut through the centre of the existing sand and cement pointing we were able to keep the arises intact, albeit that some of the existing s/c mortar remained attached at the perimeter. By using a cut to a depth of around 20mm, to that of the original lime mortar, we were then able to re-point with the new lime mortar to the original which would then allow the building to breathe correctly.

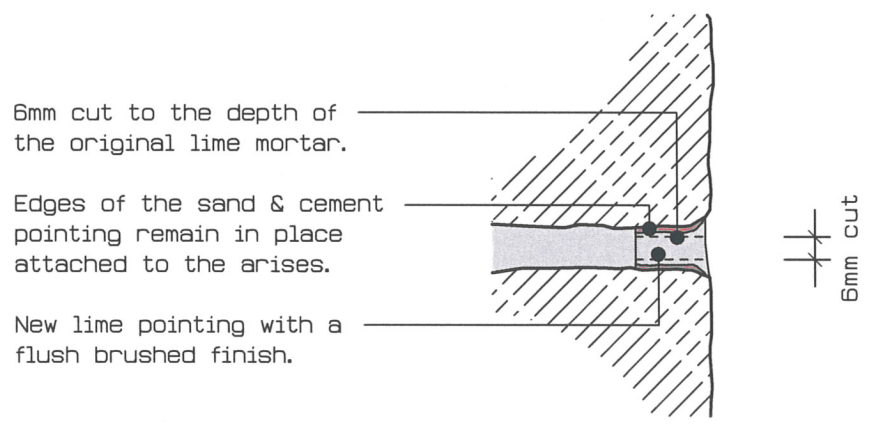
Re-pointed joints with the 6mm wide cut.

In other re-pointing works we have normally recessed the joints slightly which produces a more acceptable appearance. However, as the red sand and cement mortar was still attached to the edges of the sandstone, flush pointing with a brush finish was used to the joints.
