Refurbishment work to Willaston Memorial Hall, The Green, Willaston

Further to recent comments regarding the re-pointing works to the Memorial Hall as part of the maintenance and refurbishment work, we wish to clarify the situation to prevent further inaccuracies.

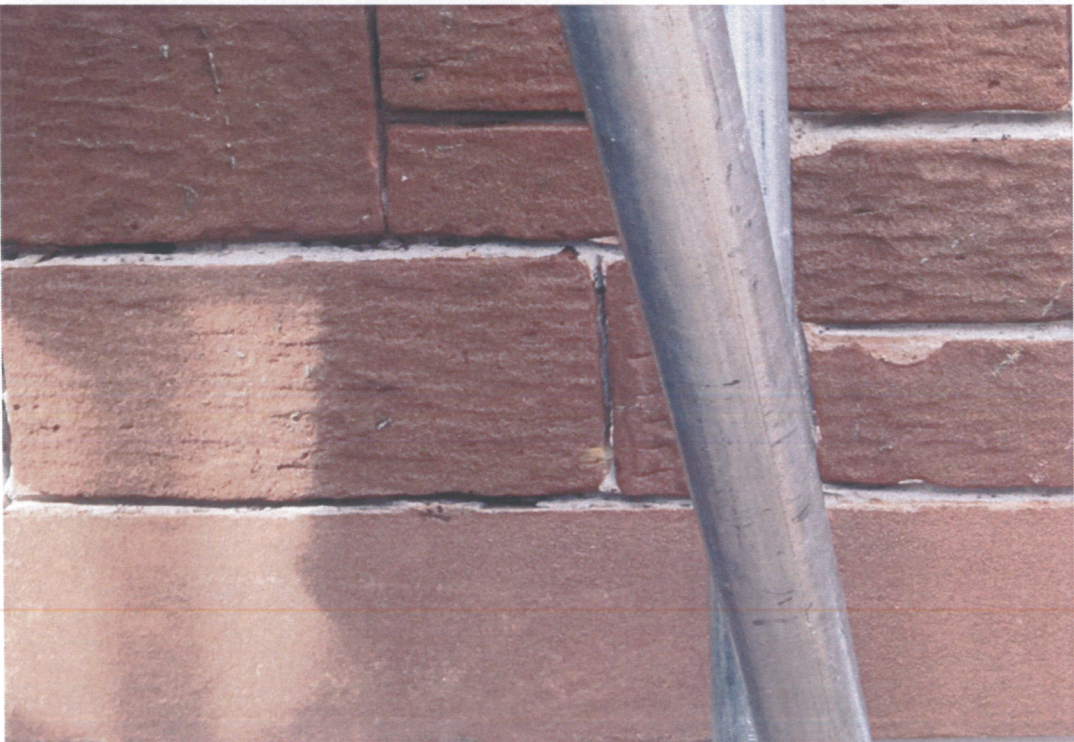
It is important to understand the reasons why the present cement pointing is deteriorating the building envelope. It is well documented that Portland cement and sand pointing, particularly stronger mixes are not porous and by their very nature shrink as they set and thermally move at a different rate to the surrounding masonry. They further cause erosion of the surrounding soft material which is clearly in evidence with the red sandstone on the Memorial Hall elevations.

The existing elevations to the front side and rear of the Memorial Hall have red sandstone facings with horizontal joints varying from 8 – 20mm, with an average of around 12mm and vertical joints, slightly narrower, at 6 – 15mm, at an average of 10mm. As stated it was important to remove the red dyed sand and cement mortar to prevent further deterioration to the red sandstone, see photographs.

In a normal situation we would not allow the use of mechanical cutters to remove old mortar but in this instance it was found that by using a thin blade cutter to cut through the centre of the existing sand and cement pointing we were able to keep the arises intact, albeit that some of the existing s/c mortar remained attached at the perimeter. By using a cut to a depth of around 20mm, to that of the original lime mortar, we were then able to re-point with the new lime mortar to the original which would then allow the building to breathe correctly.
